DUNMORE NO. 3 DAM

NDI ID NO. PA-00376

PHASE I INSPECTION REPORT
NATIONAL DAM INSPECTION PROGRAM

FEBRUARY 1979

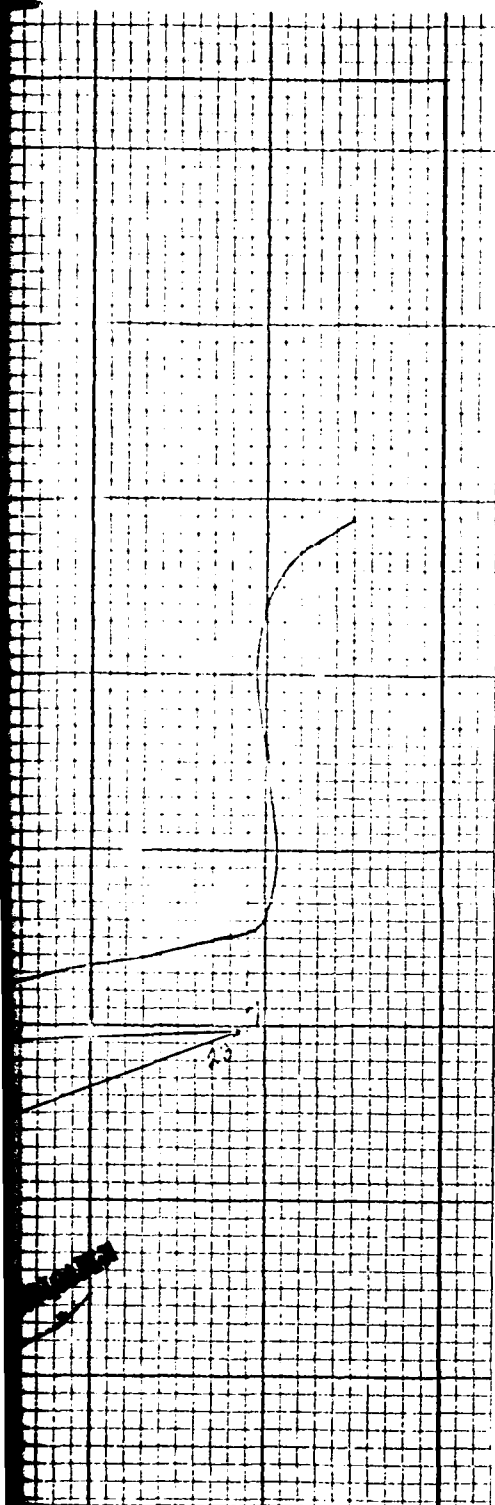
PLATE 2

The right embankment is shown on Plates 2 and 5, and on Photographs A and B. Plate 2 was drawn from survey information obtained for this inspection. No large scale plan for the right embankment was available in either the files of the Owner or in PennDER records.

As described in the survey information presented on Plates 2, 5, and 6, and in Appendix B, the upstream and downstream slopes of both embankments vary. Further discussion is presented in Section 6.

The survey information in Appendix B and Plates 2, 5, and 6 indicate that the downstream slope is uniform at any one section but varies between sections. The steepest section has a slope of 1V on 1.5H and the flattest has a slope of 1V on 2.8H. The upstream slope also varies. It is about 1V on 1.3H at the steepest section and 1V on 2.4H at the flattest section.

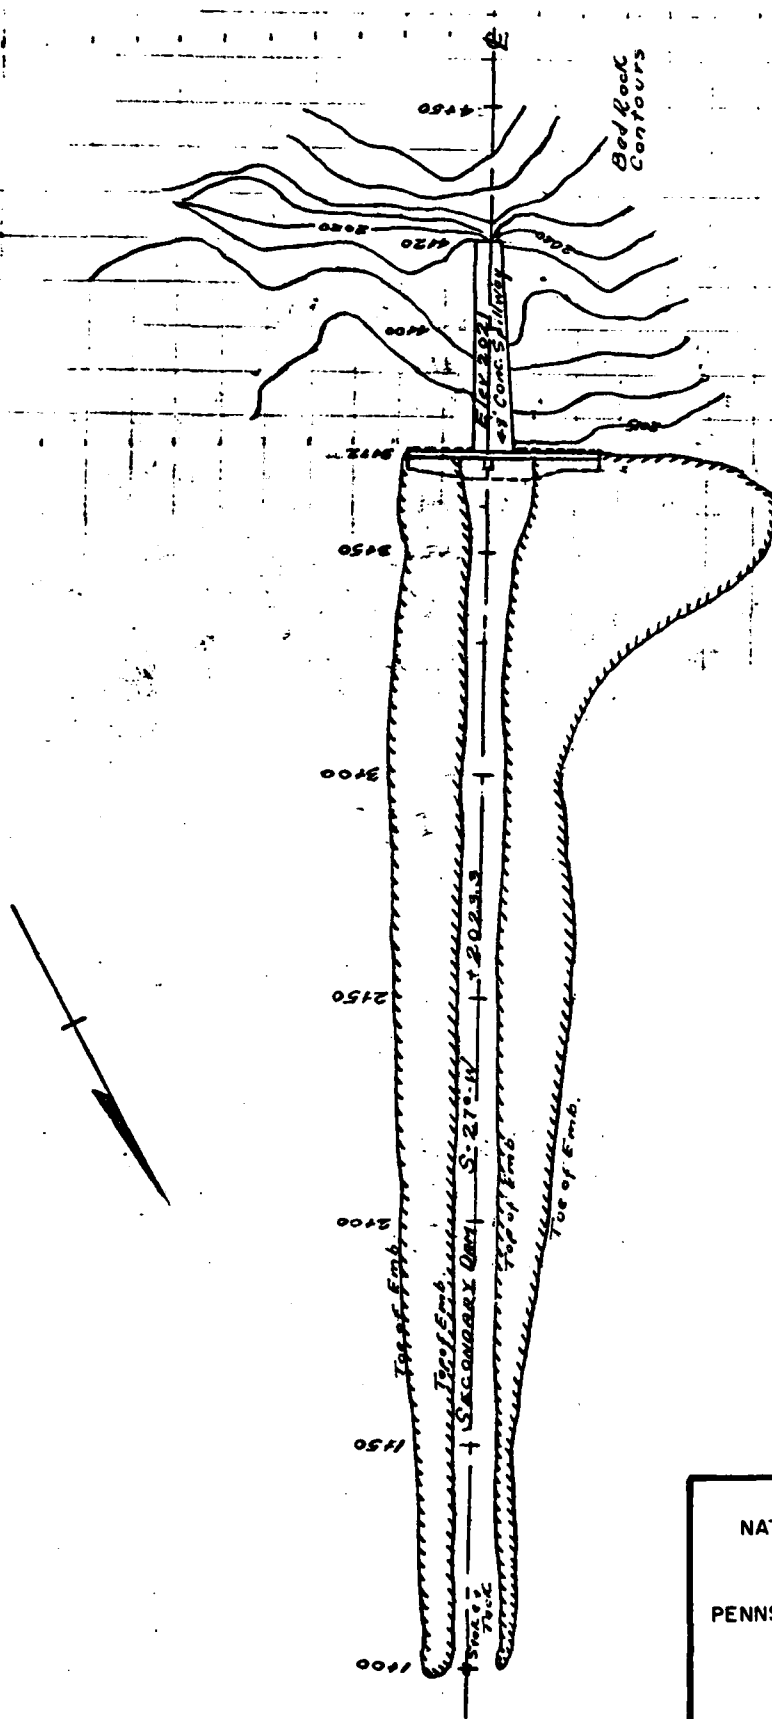
PHASE I INSPECTION REPORT
 NATIONAL DAM INSPECTION PROGRAM
 DUNMORE NO. 3 DAM
 PENNSYLVANIA GAS AND WATER COMPANY
 LEFT EMBANKMENT
 FEBRUARY 1979 PLATE 3

The left embankment is shown on Plates 3 and 6 and on Photographs D and E. Plate 3 is dated 1946 and cannot be considered a construction drawing for the embankment. This drawing was prepared for the construction of the present spillway, which was built in 1946. The details of the spillway are shown on Plate 4 and on Photograph F. The outlet works profile is shown on Plate 5. The outfall is shown on Photograph C.

Plates 3 and 6 indicate that the slopes of the left embankment vary also. The downstream slope is about 1V on 1.4H at the steepest section. The report prepared in 1914 by the Pennsylvania Water Supply Commission indicates that the right embankment had upstream and downstream slopes of 1V on 1H and 1V on 1.25H, respectively. The left embankment was described as of irregular cross section. This variation between the observed slopes and the slopes described in the report is the basis for believing that the embankment was modified in 1919.

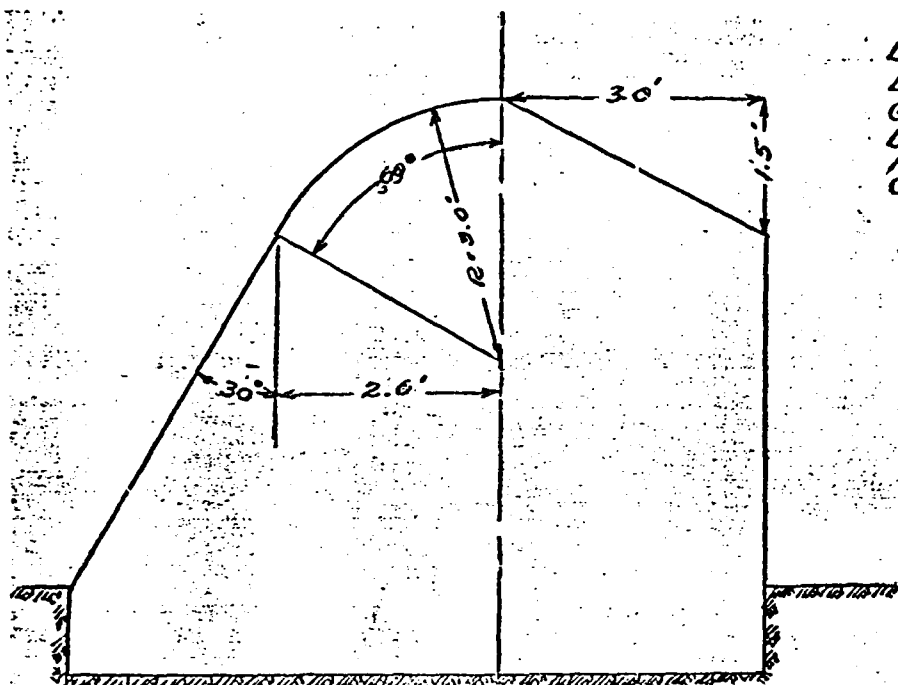
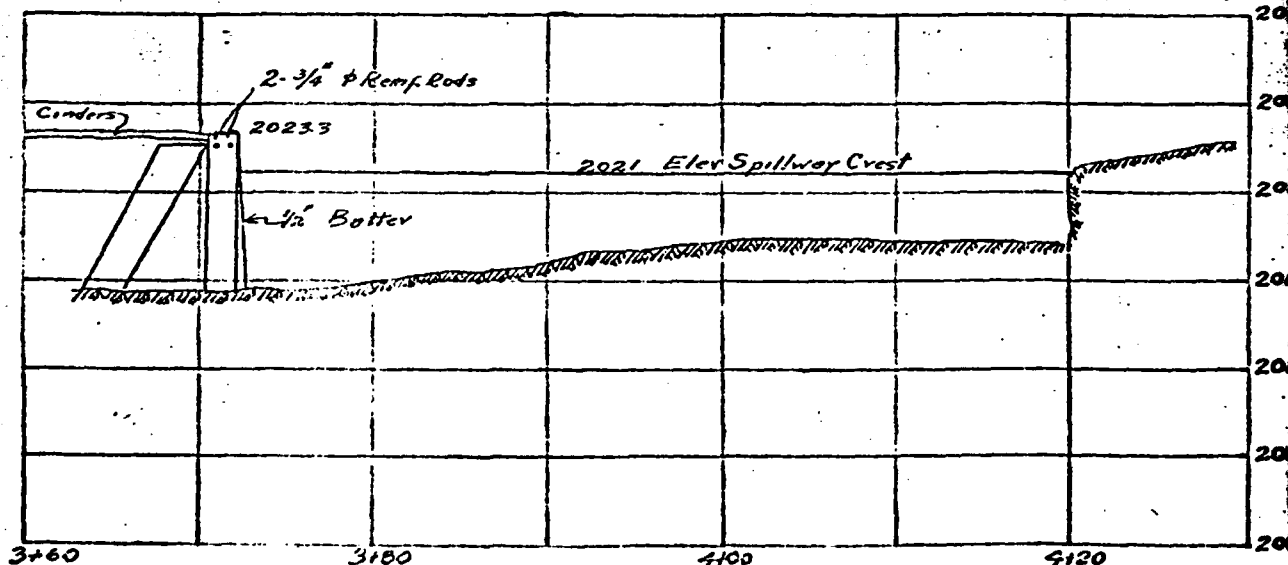
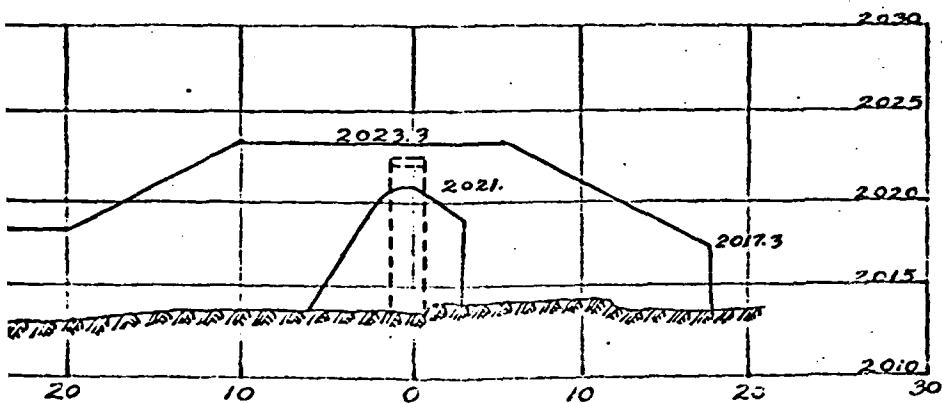
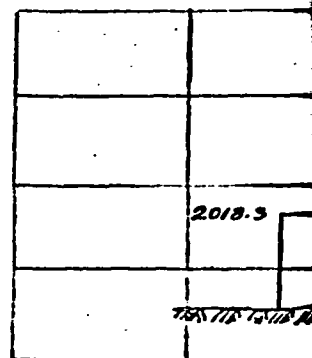
PLATE 4

The spillway is in generally good condition. At the junction of the weir and the right wall, the concrete is slightly spalled. The spillway apron downstream of the weir is a short reach of exposed bedrock. Downstream of the apron, the channel is only 1 foot deep and 3 feet wide. Substantial spillway discharges would mostly travel overland.
